# Field Guide for Potential Maternity Roost Tree (PMRT) Determinations

## 2016 Programmatic Agreement for Indiana Bat and Northern Long-eared Bat

## 2016 Indiana bat and northern long-eared bat Programmatic Agreement/Programmatic Biological Opinion (PA/PBO) – Technical Guidance<sup>1</sup>

### **Preliminary Bat Assessment Guidelines for Bridges/Structures and Bridge Bat Inspection Form.**

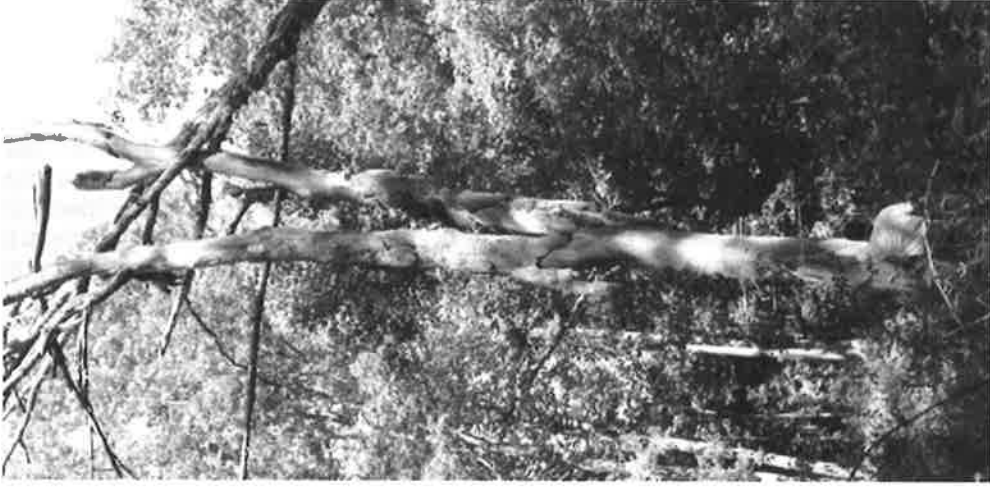
Dead American elm with solar exposure and several areas of peeling bark

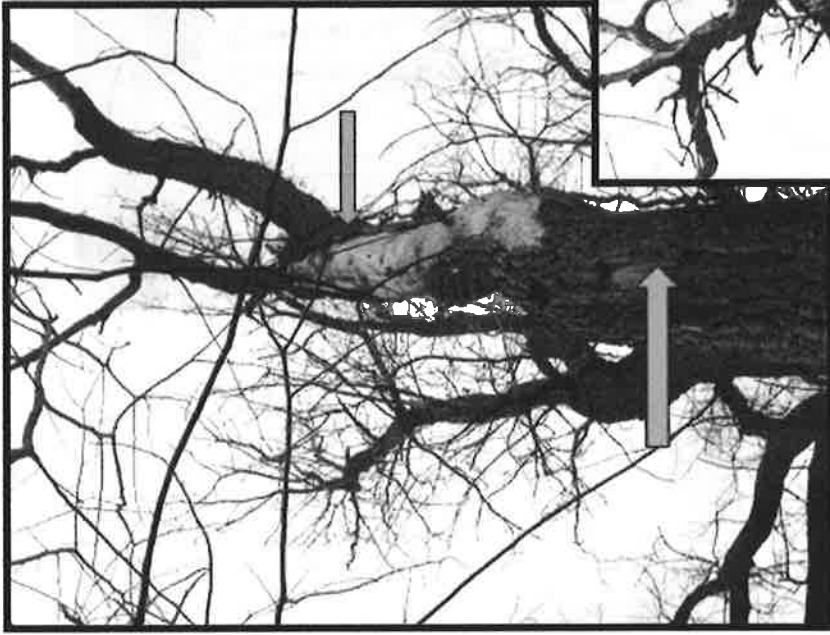
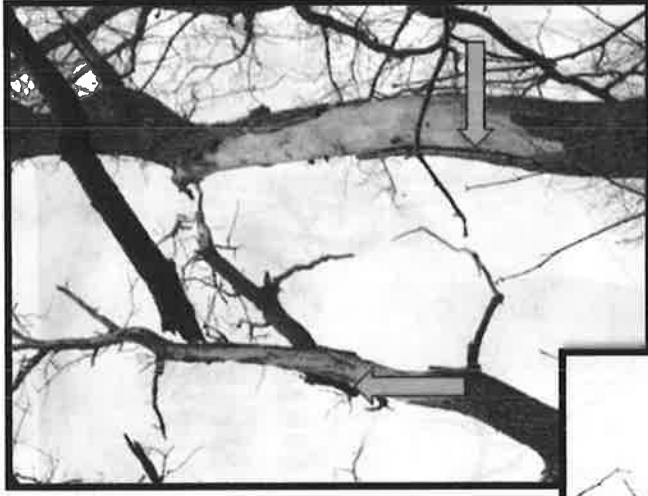
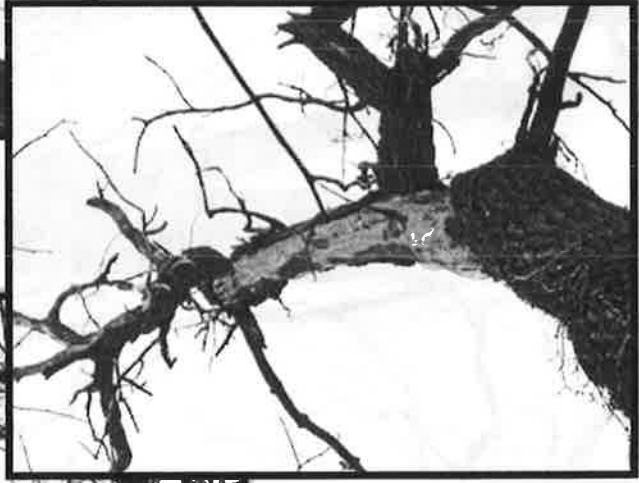
Close-up photos showing areas of habitat on the large cottonwood shown on the previous page.

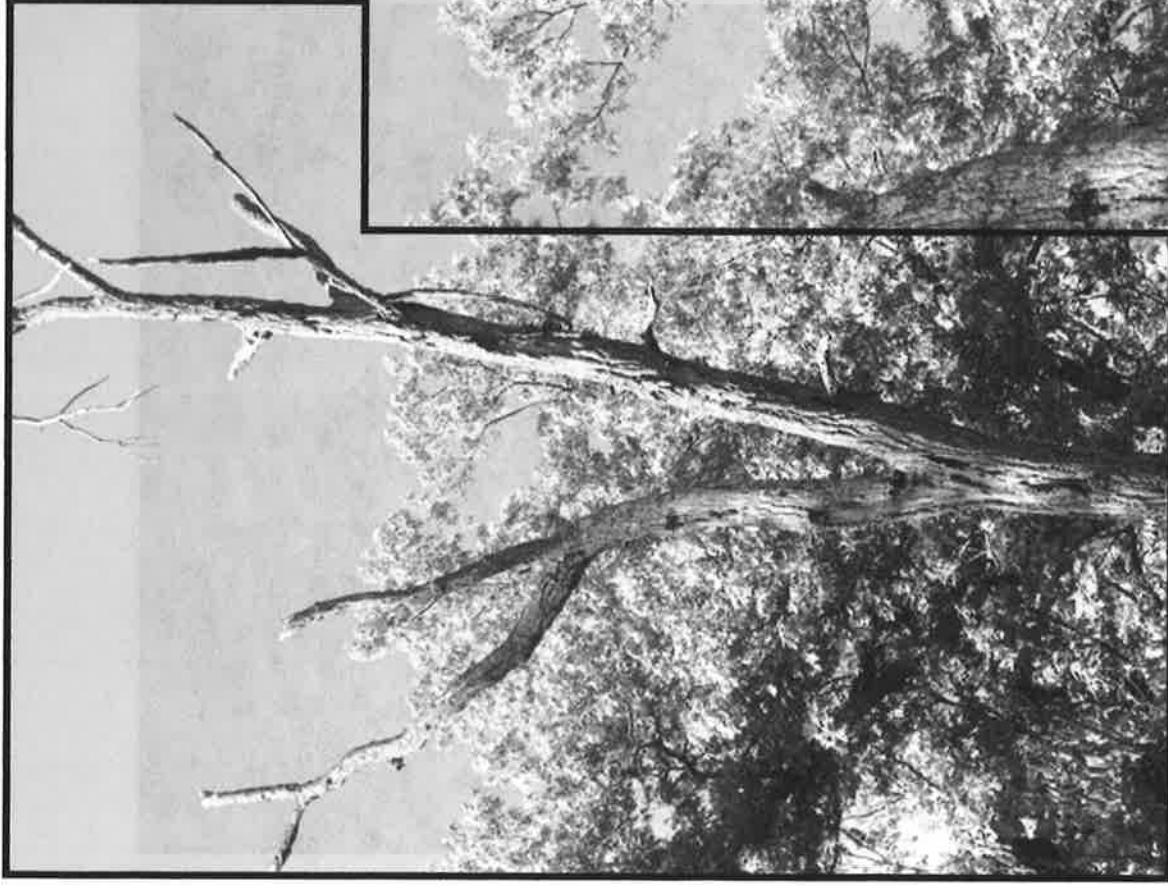
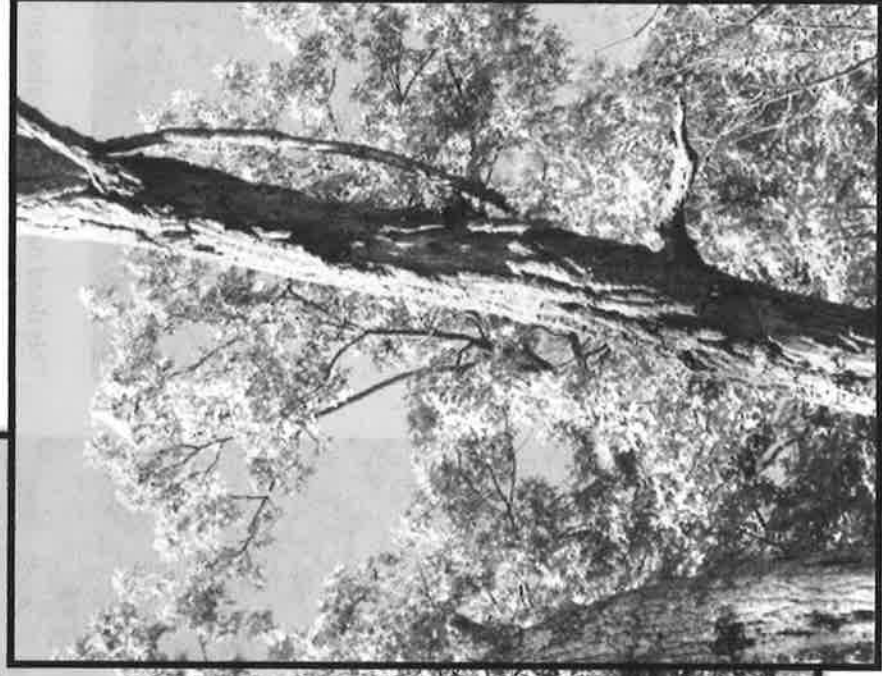
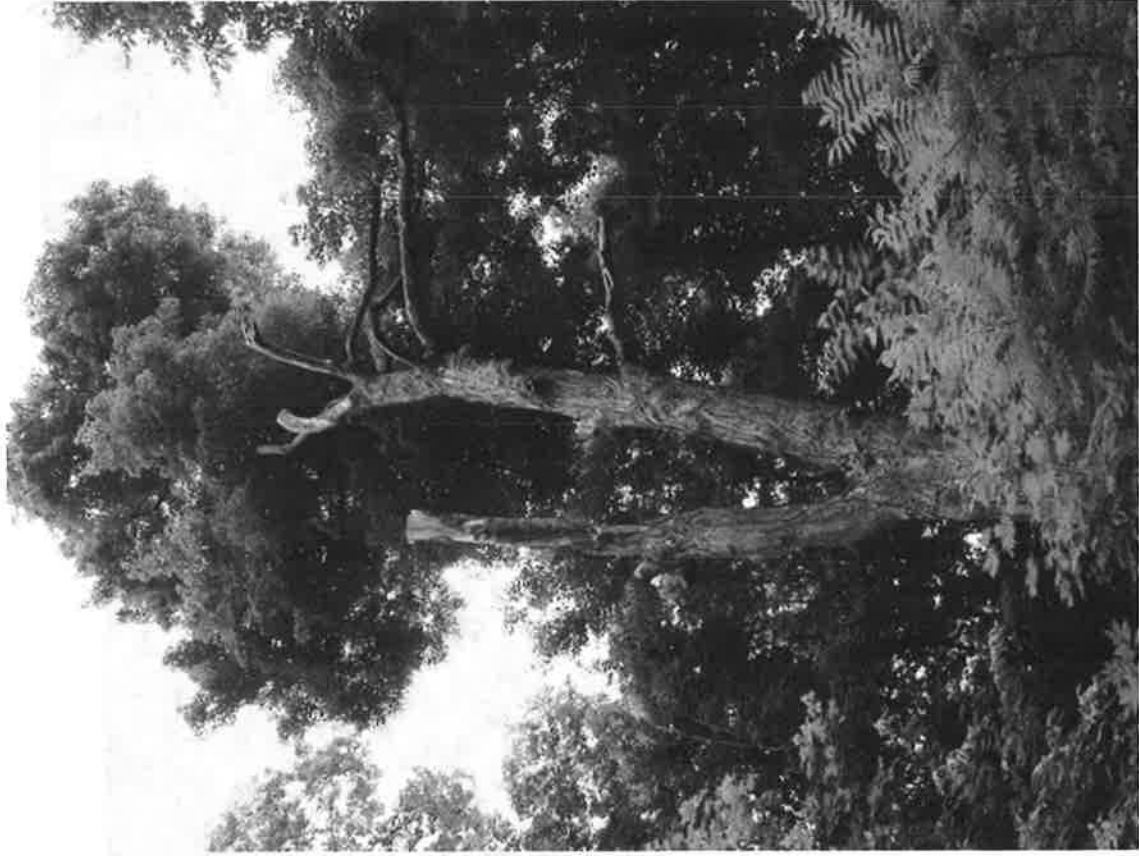
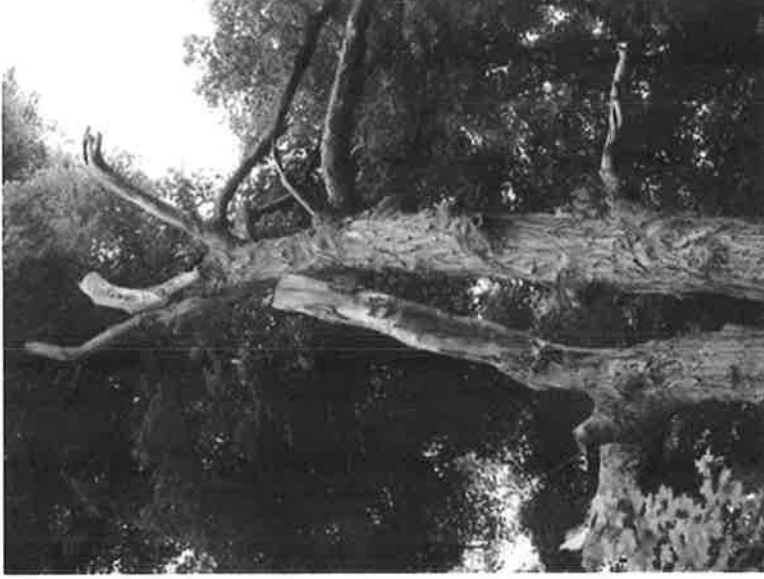
Dead chestnut oak located in a woodlot. This tree receives solar exposure because it is a super-canopy tree. This tree has large areas of peeling bark scattered around the entire tree. This tree offers a great variety of both sunny and shady areas to aid in thermoregulation.

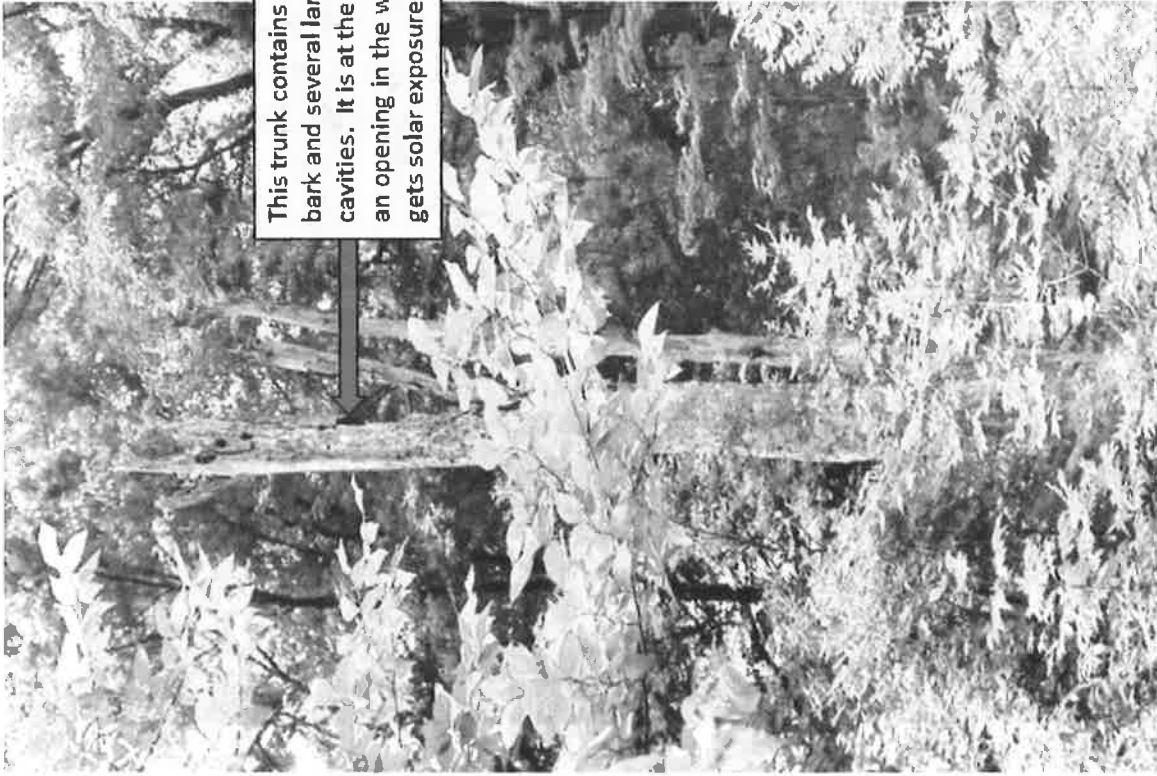
Large dead green ash located at the edge of a wetland. This tree gets several hours of solar exposure and contains many slabs of separated bark.

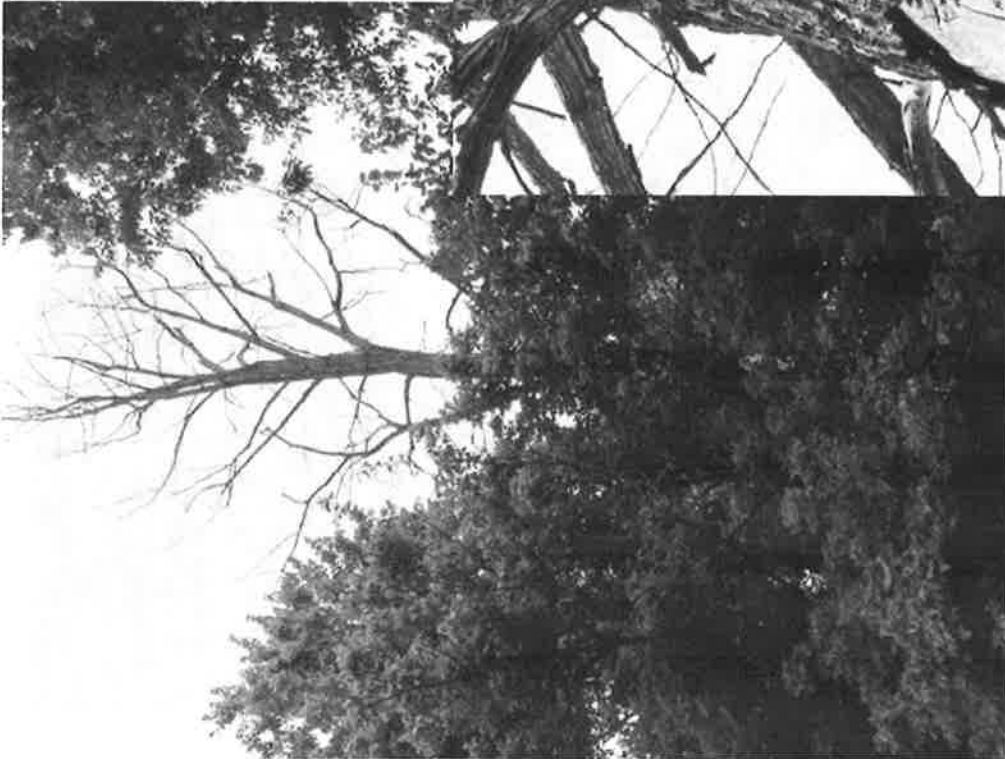
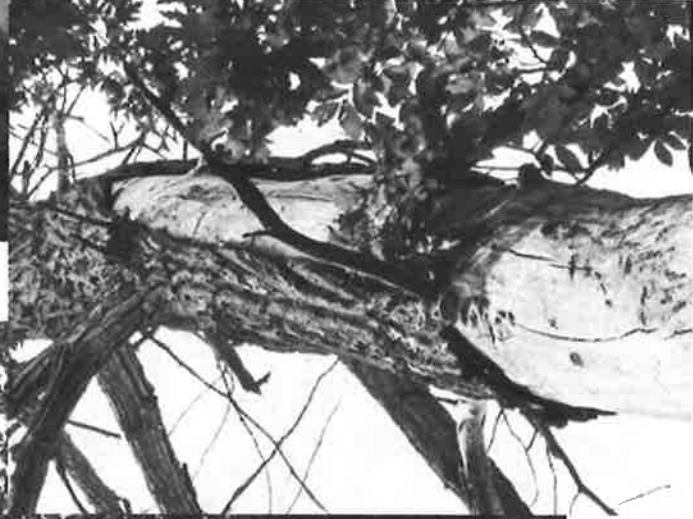
Large super-canopy dead ash tree. The roosting habitat in this tree is not apparent until viewed from below. Looking at trees from all angles is important in determining the quality of the roosting habitat.

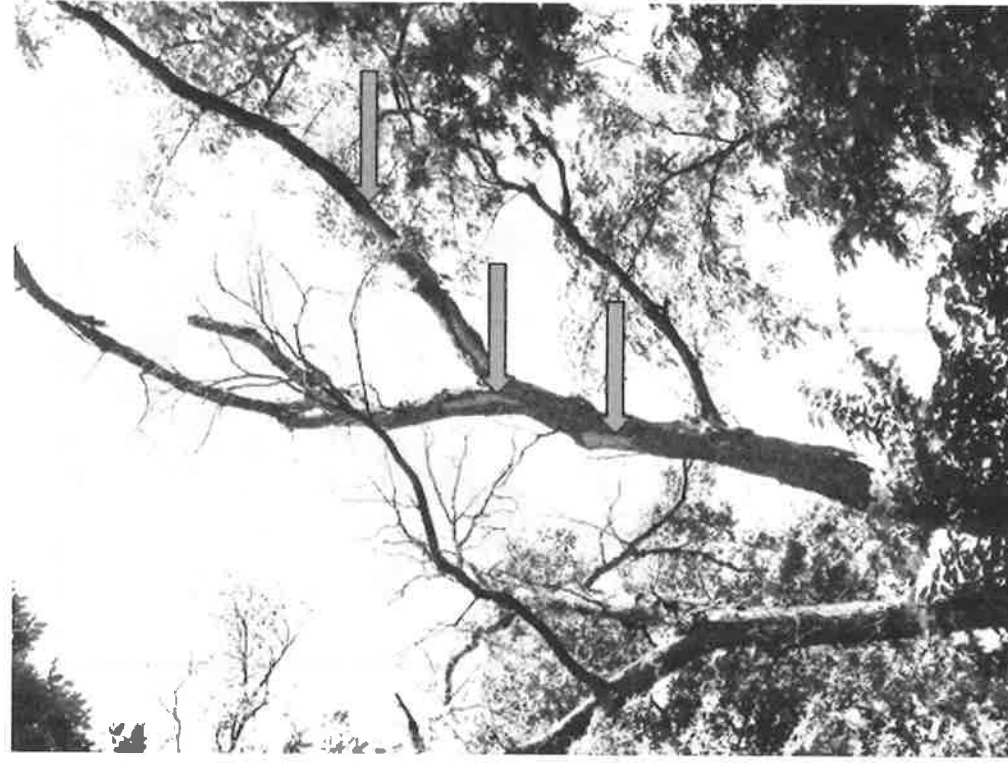
When roosting habitat is located only on the branches, the branches must be at least 8 inches in diameter at the location of the habitat. The blue arrows in the photo show areas that may offer maternity roosting habitat. The red arrows show areas of peeling bark that would most likely not be used because of the small diameter of the branch.

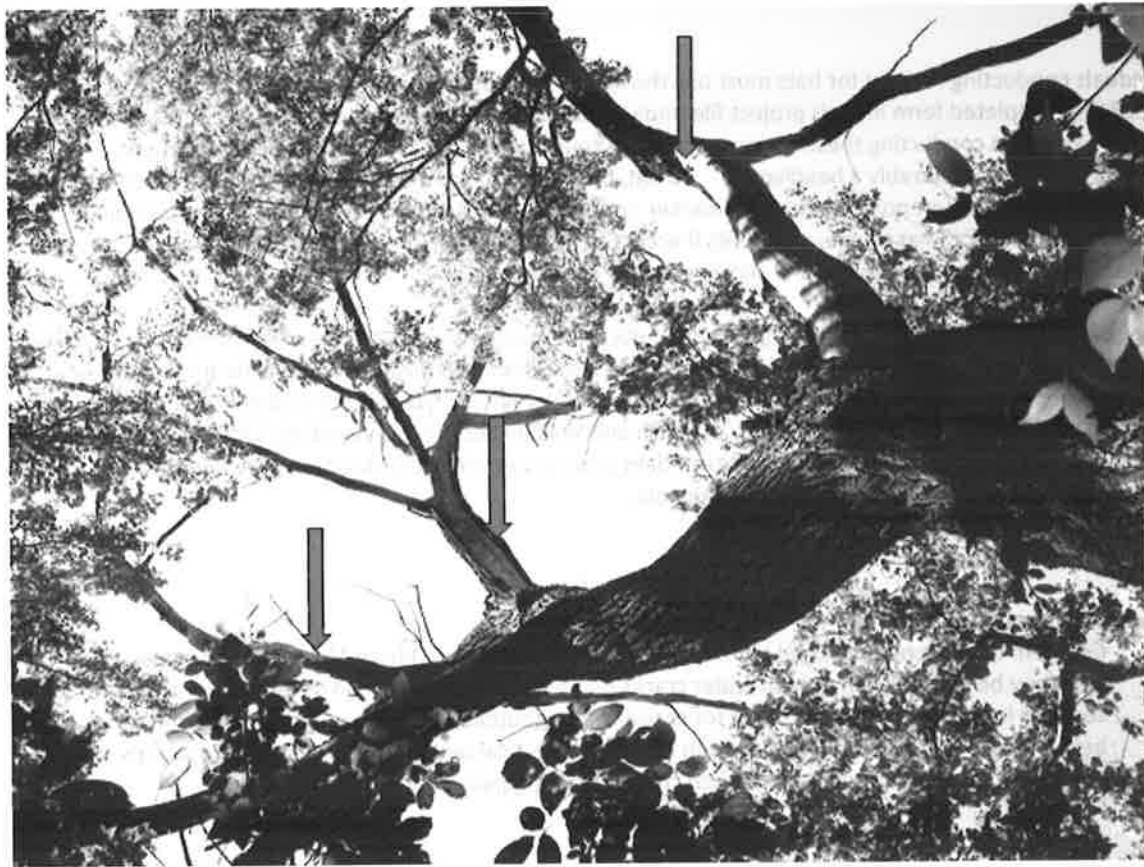
Large dying silver maple that offers several areas of peeling bark with varying levels of solar exposure.

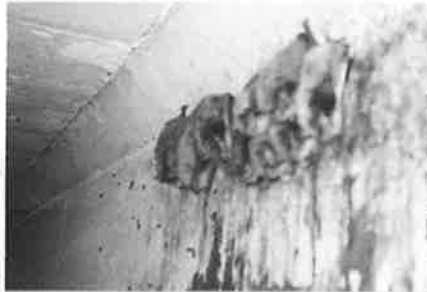
Photo 1: Bats hanging from cracks along Support beams

Cracks in the concrete are used by bats as a foothold in roosting (Photo 1). In addition, some bats may be hidden from sight in wider cracks in the concrete and behind deteriorating concrete sections in the ceiling or walls. Look for cracking along support beams and inner walls especially below a fillet (a concrete filling between ceiling and vertical beam). During inspection, sounds may be heard coming from behind such cracks and/or expansion joints.

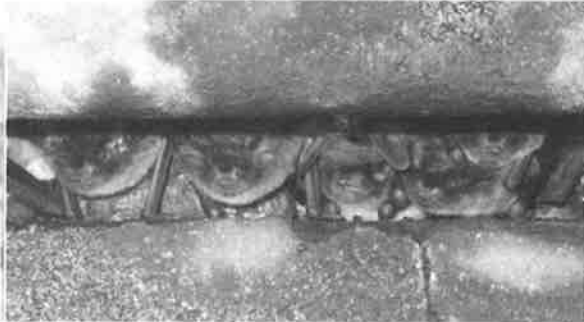
Photo 2: Visible bats within an expansion joint

Expansion joints can provide protected cover for bats (Photos 2 and 3), but do not always provide habitat, depending upon whether they are obstructed by road debris or other blockages to use. If possible during the inspection, individuals should look into expansion joints or in other cracks with a flashlight. If joints are used by bats, often there will be guano under the joints (Photos 4-6), but not always, since the joint may be located over water.

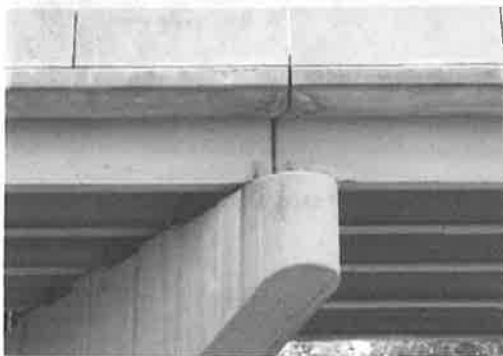
Photo 3: Example of open concrete joint used by bats

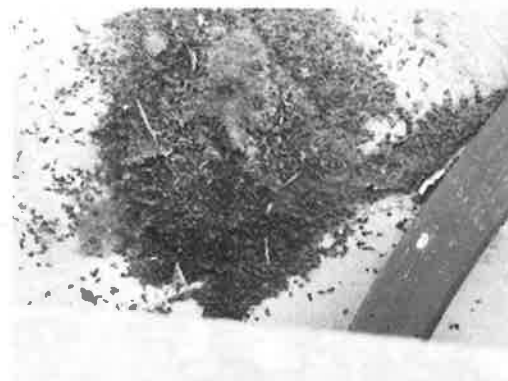
Photo 4: Guano deposits visible from bridge deck, on top of pier

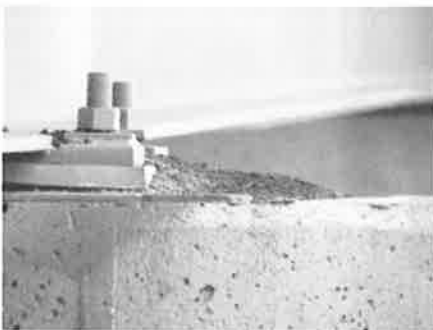
Photo 5: Guano deposit on pier, obscuring structural features.

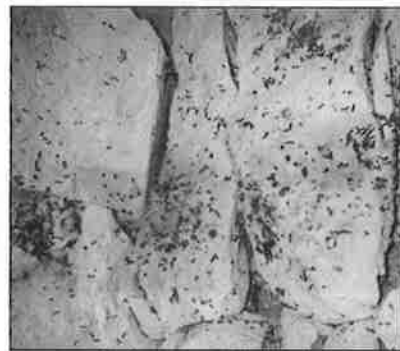
Photo 6: Bat Guano on Riprap

Bat droppings are small (mouse-like in appearance but less regular) brown or black pellets (Photos 6 - 8). Older droppings may be gray in color. These droppings will accumulate on the ground, floor of a covered bridge or on structural components below where bats roost. Droppings may also adhere to support beams and walls below roosts.

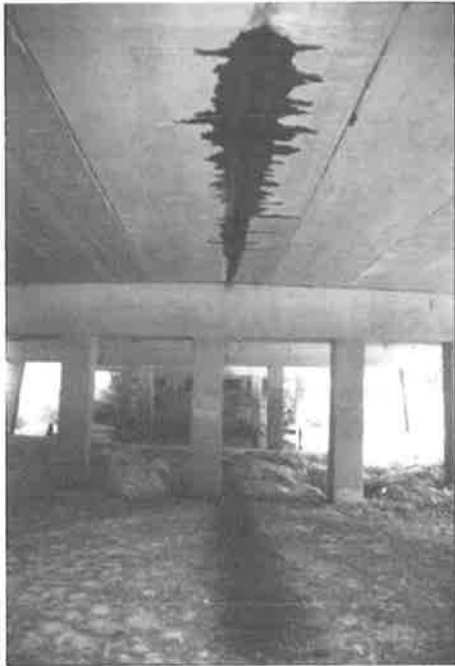
Photo 7: Staining along longitudinal joint. Note guano deposits on the ground.

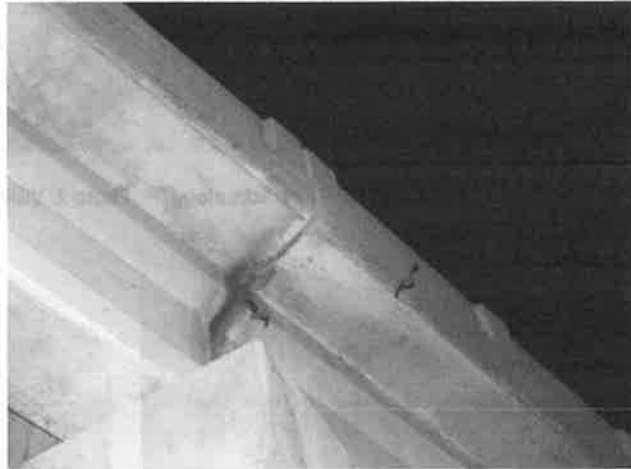
Photo 8: Staining on underside of expansion joint from bat use.

Stains may appear wet and are usually found in dark places. Look for four to six inch wide dark stains located on concrete support beams and walls immediately below the ceiling of the bridge, and beneath joints (Photos 8 - 11).

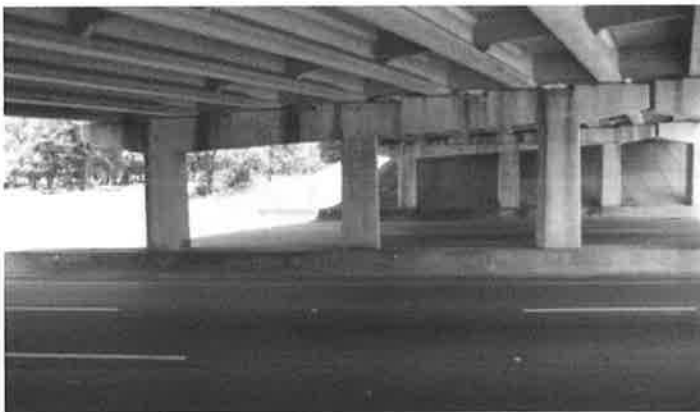
Photo 9: Staining on sides of pier caps

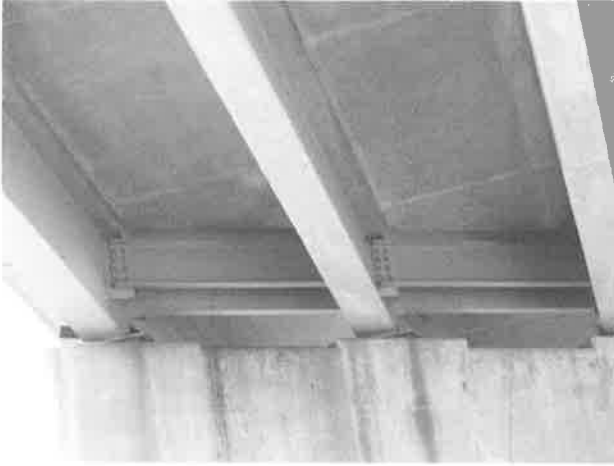
Photo 10: Guano staining on side of pier

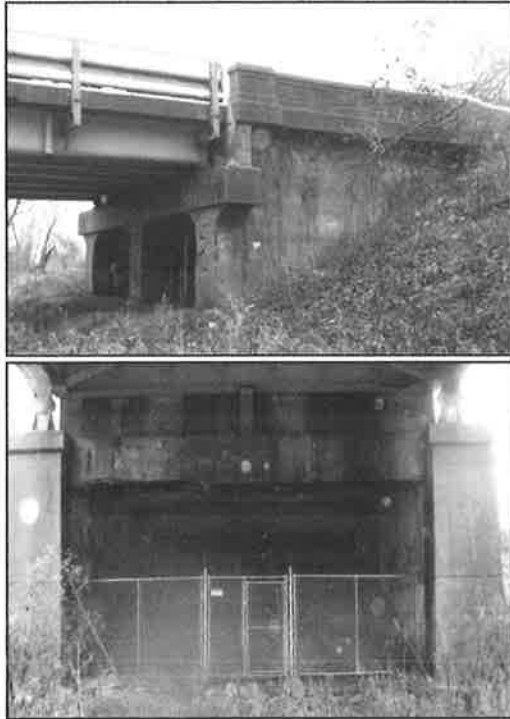
**Photo 12 and 13: Bridge Design Mimicking “Cave-like” Atmosphere**

While inspecting bridges, look for dark environments that mimic cave-like conditions such as under the deck of the bridge (Photos 12 and 13). This may involve crawling under low areas so a hard hat is recommended. Such places (e.g., a concrete bunker secreted into a hillside with an open front) provide protection from wind, rain, sleet, hail and predators. Bats do not roost near the ground where predators (cats, raccoons, etc.) can reach them. Roosting is usually at least 4 feet from the ground.

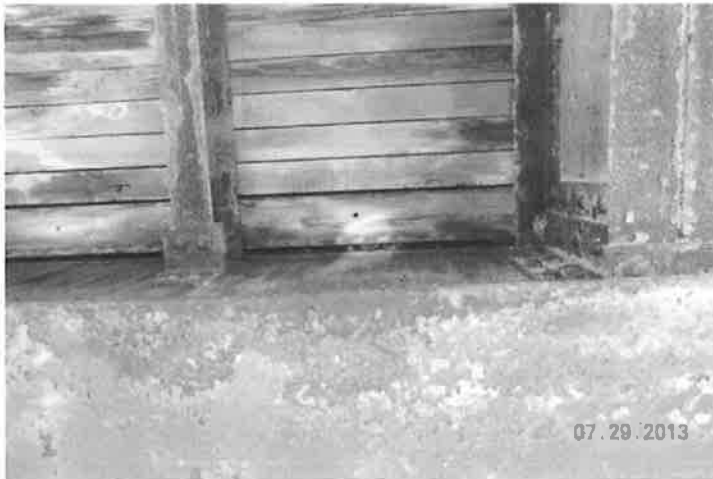
**Photo 14: NLEBs Roosting Under a Timber Decked Bridge**
